Consumer Products

Service Information

Factory: John Deere Horicon Works

TR800 CLUTCH BUSHINGS

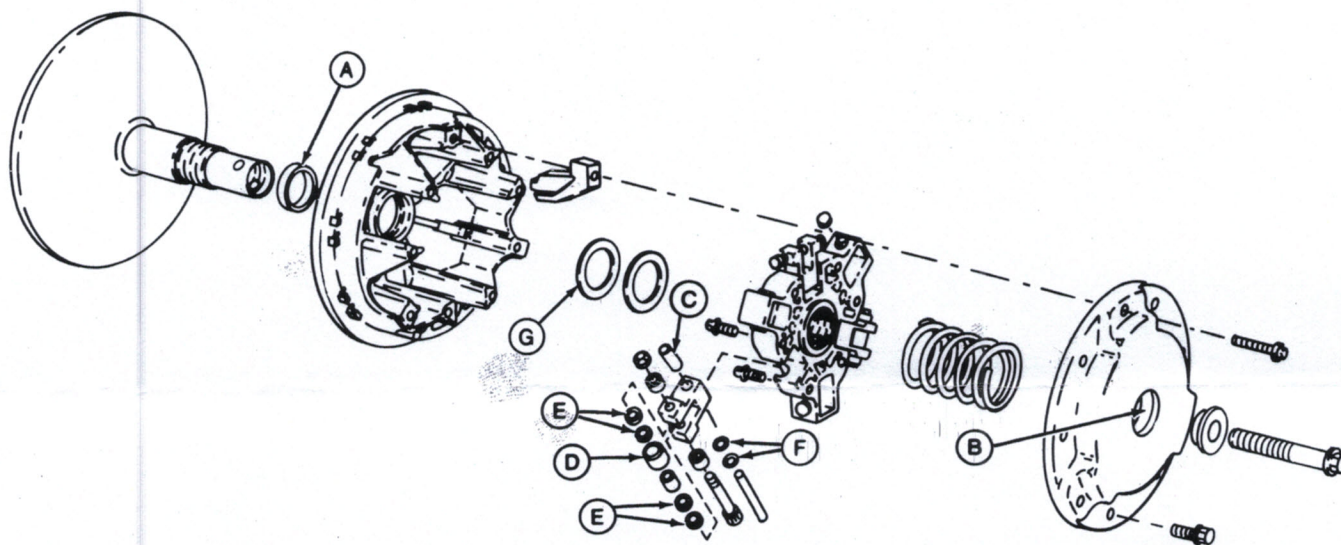
M69328 roller arm loose and/or poor clutch performance.

Moveable sheave bushing M68859 (A) and cover bushing M68862 (B) become loose in their housings and/or wear, causing accelerated wear of the arm roller bushings and their thrust washers.

When replacing arm bushing M69329 (C), roller AM55473 (D), or thrust washers AM55474 (E) and AM55563 (F), always inspect moveable sheave bushing M68859 (A) and cover bushing M68862 (B). Replace bushings if worn, loose, or if staking is not secure. Install larger diameter washer M69706 (G) behind the spider if it has not already been installed.

TR800 clutches used on 1982 Model Liquifires were produced with a black cover. The 1983 Model Liquifires were produced with TR800's having silver covers. Silver cover clutches had bushing M68859 loctited in place and improved staking. In addition, a running change during 1983 production put the larger diameter washer (M69706) behind the spider to prevent the staking from being worn away.
